PHOTOGRAPHIC SURVEY OF THE LDEF MISSION

NASA Special Publication 531

Robert L. O'Neal

Langley Research Center
Hampton, Virginia 23681-0001

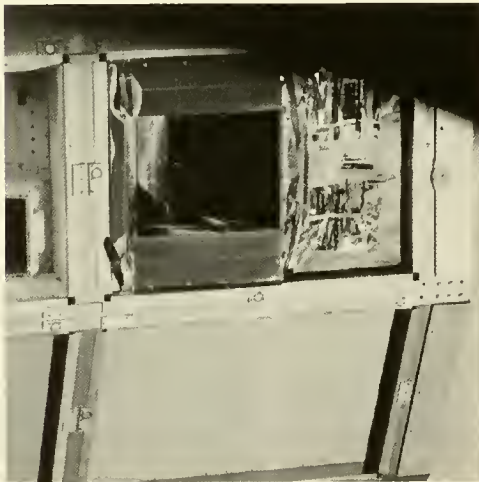
Figure 475 (In Flight). A portion of the greenish-gray tint on the two debris panels is a by-product of the chromic anodize coating process; however, a large part can be attributed to reflections of the blue sky. The vertical streaks in the panels are by-products of chromic anodizing that have been enhanced significantly by the blue reflection. Two darker blue horizontal discolorations are visible near the vertical center of each panel.

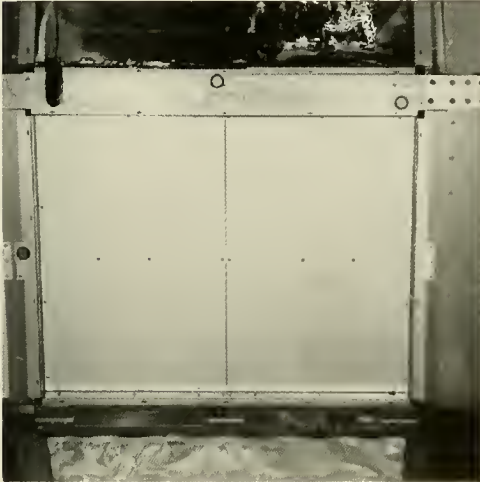
Figure 476 (Postflight). The pink and greenish-gray tints on the two debris panels are by-products of the chromic anodize coating process and are not attributed to contamination or exposure to the space environment. The vertical streaks that were on the panels in the in-flight photograph are still visible, but they are much lighter because the reflection of the sky is not present. The same can be said for the two discolorations; they are still visible, but are much lighter. The light band along the sides and across the bottom of the panels is caused by light reflecting from the tray sidewalls.

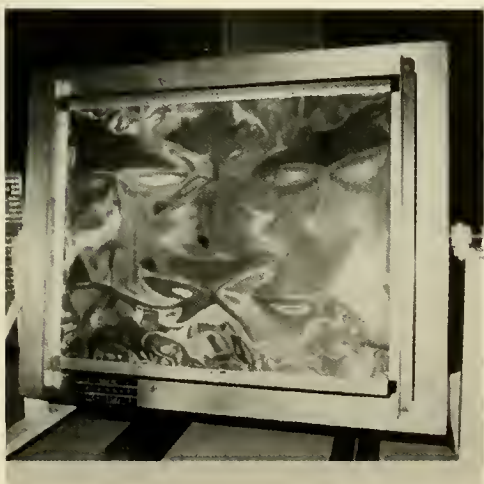
Figure 478
Photo No.: KSC-384C-299.05
Dup. Neg. No.: L84-7150
LISAR No.: EL-1994-00199
Photo Credit: KSC
Photo Date: 1/19/84
Location: KSC SAEF II
Subject: Preflight Survey of Tray F2

Figure 478 (Preflight). This photograph is of the tray after the thermal cover was installed. Thermal control was accomplished by using a thin (5 mil) silvered Teflon thermal cover of material identical to that used for the 16 trays of experiment AO178. Because the thermal cover is highly reflective, it mirrors images, lights, and colors from the area surrounding the tray.

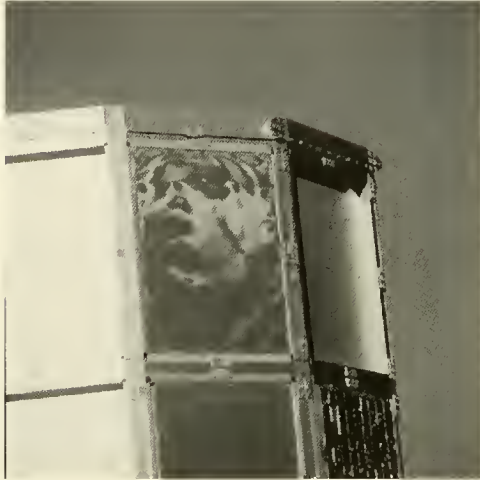
Figure 479
Photo No.: S32-89-023
Dup. Neg. No.: L90-10497
LISAR No.: EL-1994-00132
Photo Credit: JSC
Photo Date: 1/12/90
Location: In Flight
Subject: In-Flight Survey of Tray F2

Figure 479 (In Flight). The silvered Teflon thermal cover appears to be without physical damage. The three dark spots appearing in a vertical row about a third of a tray width from the right edge of the cover are three Velcro attachment pads. The lighter areas appear diffuse in other photographs.

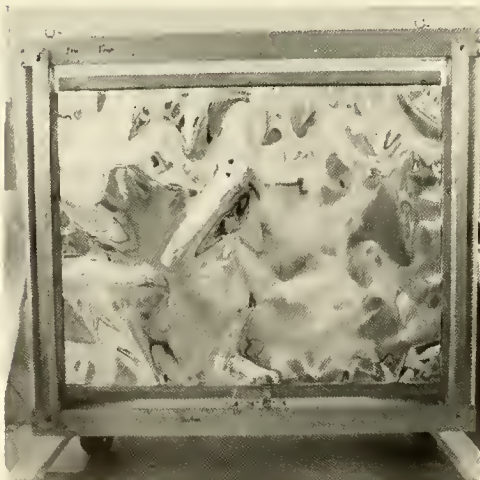
Figure 480
Photo No.: KSC-390C-1465.03
Dup. Neg. No.: L91-1553
LISAR No.: EL-1994-00193
Photo Credit: KSC
Photo Date: 2/23/90
Location: KSC SAEF II
Subject: Postflight Survey of Tray F2

Figure 480 (Postflight). The silvered Teflon thermal cover is without physical damage. The surroundings are reflected in the surface of the thermal cover. In general, the thermal cover appears specular except for an area in the lower center of the tray, which appears to be somewhat dull. A similar condition was noted on the thermal cover of tray A2 at the other end of the LDEF.

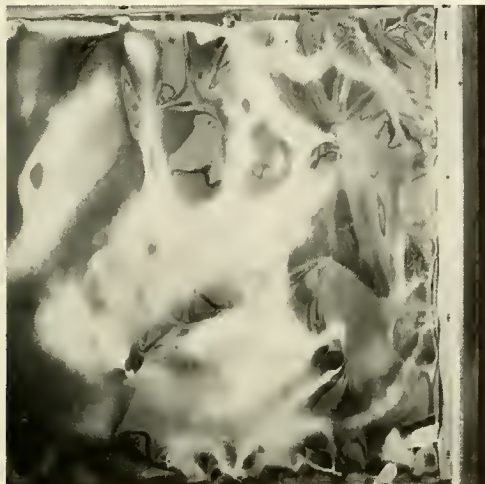
Figure 481
Photo No.: KSC-390C-1465.05
Dup. Neg. No.: L91-1555
LISAR No.: EL-1994-00389
Photo Credit: KSC
Photo Date: 2/23/90
Location: KSC SAEF II
Subject: Postflight Detail of Diffuse Area of Tray F2

Figure 481 (Postflight). This close-up photograph is of the diffuse area of the thermal cover. Surrounding areas are specular and reflect nearby surroundings.

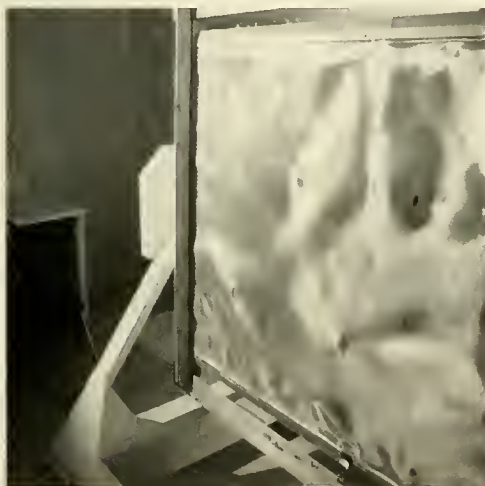
Figure 482
Photo No.: KSC-390C-1465.07
Dup. Neg. No.: L91-1557
LISAR No.: EL-1994-00390
Photo Credit: KSC
Photo Date: 2/23/90
Location: KSC SAEF II
Subject: Postflight Detail of Diffuse Area of Tray F2

Figure 482 (Postflight). This oblique view of the thermal cover shows the diffuse area of the thermal cover.

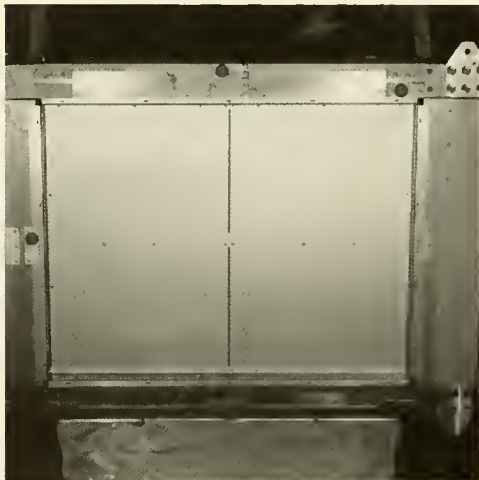
Figure 483 (Postflight). The pink and greenish-gray tints on the two debris panels are by-products of the chromic anodize coating process and are not attributed to contamination or exposure to the space environment. The light band along the sides and across the bottom of the panels is caused by light reflecting from the tray sidewalls.

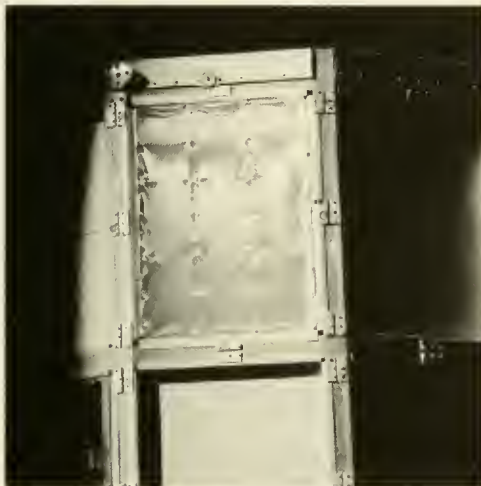
Figure 484 (In Flight). The thermal cover appears to be specular and intact with several small circular areas that appear to be impacts. The cover is more taut than in the prelaunch photograph. The wrinkled spots on the thermal cover are areas where Velcro attachment pads are bonded to the back of the cover. The scalloped effect around the cover edges occurs between the attachment pads. The ground strap is in place and has no visible damage.

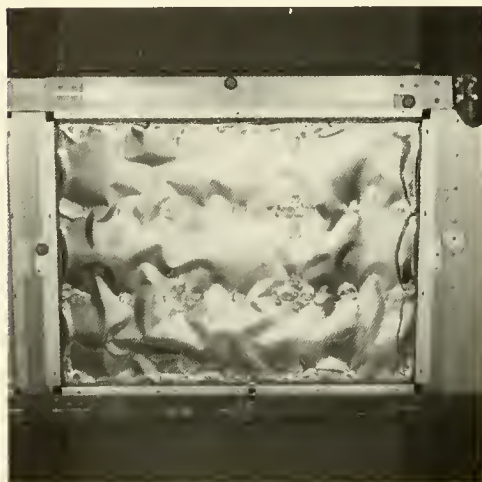
Figure 485
Photo No.: KSC-390C-832.02
Dup. Neg. No.: L90-13349
LISAR No.: EL-1994-00171
Photo Credit: KSC
Photo Date: 2/7/90
Location: KSC SAEF II
Subject: Postflight Survey of Tray F4

Figure 485 (Postflight). The thermal cover appears to be specular and intact. Because of lighting, the locations that appeared to be impacts in the in-flight photograph are not apparent. The thermal cover is less taut than in the in-flight photograph. The wrinkled spots on the thermal cover are areas where Velcro attachment pads are bonded to the back of the cover. The scalloped effect around the cover edges occurs between the attachment pads. The ground strap is in place with no visible damage, but it appears darker.

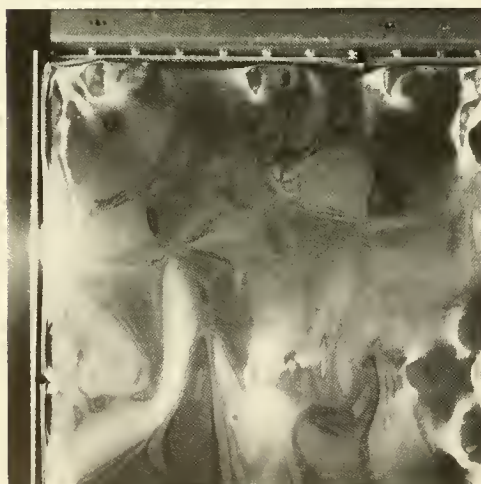
Figure 486
Photo No.: KSC-390C-2212.05
Dup. Neg. No.: L91-10848
LISAR No.: EL-1994-00536
Photo Credit: KSC
Photo Date: 3/22/90
Location: KSC SAEF II
Subject: Postflight Detail of Upper Left of Tray F4

Figure 486 (Postflight). This photograph is of the upper left one-sixth of the tray. The thermal cover appears specular with no apparent damage. There seemed to be no opaqueness on the third of the tray. The reflective properties of the uneven surface of the cover result in various light and color patterns. A very few impact or penetration discolorations are visible. The Velcro attachment pads are evident.

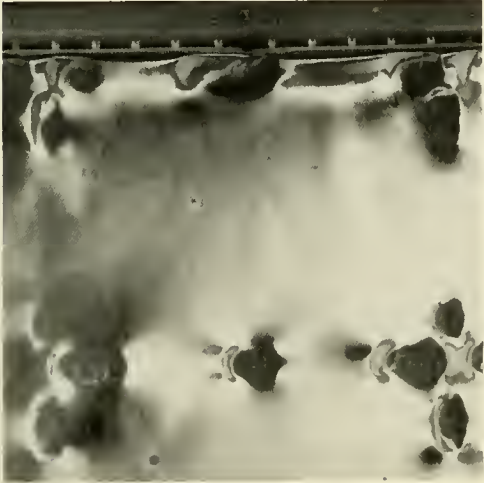
Figure 487
Photo No.: KSC-390C-2212.06
Dup. Neg. No.: L91-10849
LISAR No.: EL-1994-00537
Photo Credit: KSC
Photo Date: 3/22/90
Location: KSC SAEF II
Subject: Postflight Detail of Upper Center of
Tray F4

Figure 487 (Postflight). This photograph is of the upper center one-sixth of the tray. The thermal cover has no apparent damage; however an area of some opaqueness is beginning to appear. The reflective properties of the uneven surface of the cover result in various light and color patterns. A very few impact or penetration discolorations are visible. The Velcro thermal cover attachment pads are evident.

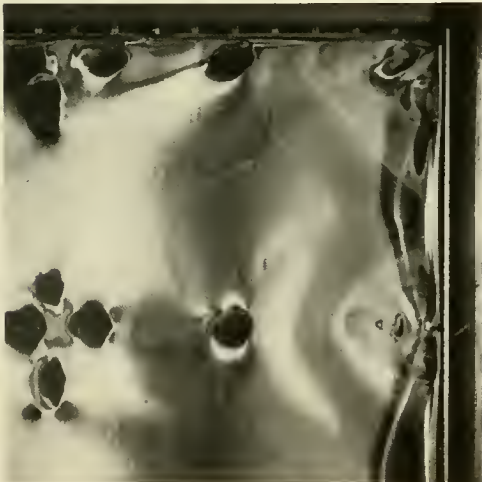
Figure 488
Photo No.: KSC-390C-2212.07
Dup. Neg. No.: L91-10850
LISAR No.: EL-1994-00538
Photo Credit: KSC
Photo Date: 3/22/90
Location: KSC SAEF II
Subject: Postflight Detail of Upper Right of Tray F4

Figure 488 (Postflight). This photograph is of the upper right one-sixth of the tray. The thermal cover has no apparent damage; however an area of some opaqueness is beginning to appear. The reflective properties of the uneven surface of the cover result in various light and color patterns. A very few impact or penetration discolorations are visible. The Velcro attachment pads are evident.

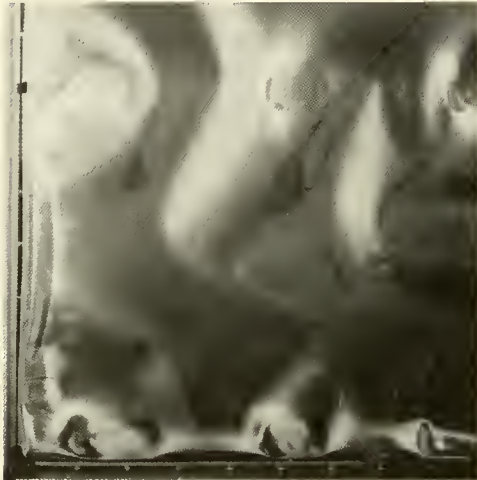
Figure 489
Photo No.: KSC-390C-2212.11
Dup. Neg. No.: L91-10854
LISAR No.: EL-1994-00539
Photo Credit: KSC
Photo Date: 3/22/90
Location: KSC SAEF II
Subject: Postflight Detail of Lower Left of Tray F4

Figure 489 (Postflight). This photograph is of the lower left one-sixth of the tray. The thermal cover appears specular with no apparent damage. The opaqueness on other parts of the tray is not present here. The reflective properties of the uneven surface of the cover result in various light and color patterns. A very few impact or penetration discolorations are visible. The Velcro attachment pads are evident.

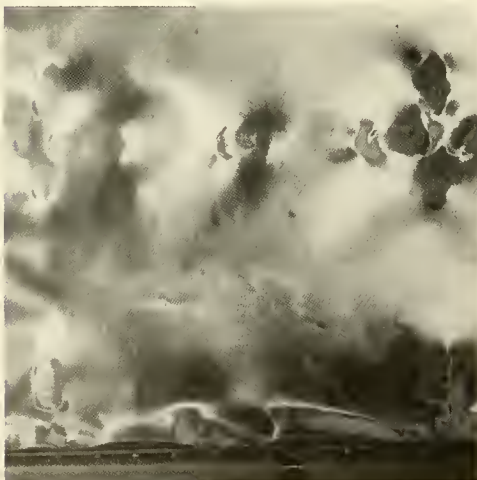
Figure 490
Photo No.: KSC-390C-2212.12
Dup. Neg. No.: L91-10855
LISAR No.: EL-1994-00540
Photo Credit: KSC
Photo Date: 3/22/90
Location: KSC SAEF II
Subject: Postflight Detail of Lower Center of
Tray F4

Figure 490 (Postflight). This photograph is of the lower center one-sixth of the tray. The thermal cover has no apparent damage; however an area of some opaqueness is beginning to appear. The reflective properties of the uneven surface of the cover result in various light and color patterns. A very few impact or penetration discolorations are visible. The Velcro attachment pads are evident.

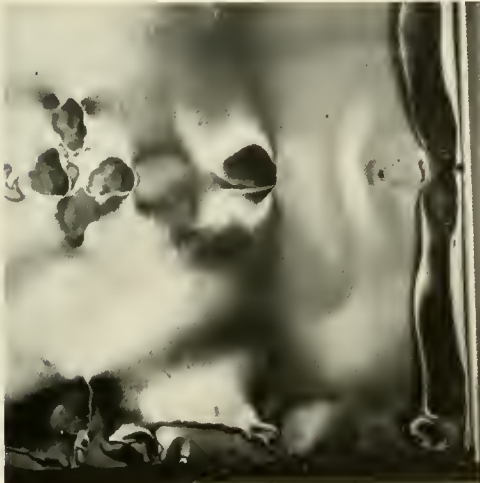
Figure 491 (Postflight). This photograph is of the lower right one-sixth of the tray. The thermal cover appears specular with no apparent damage; however an area of some opaqueness is beginning to appear. The reflective properties of the uneven surface of the cover result in various light and color patterns. A very few impact or penetration discolorations are visible. The Velcro attachment pads are evident.

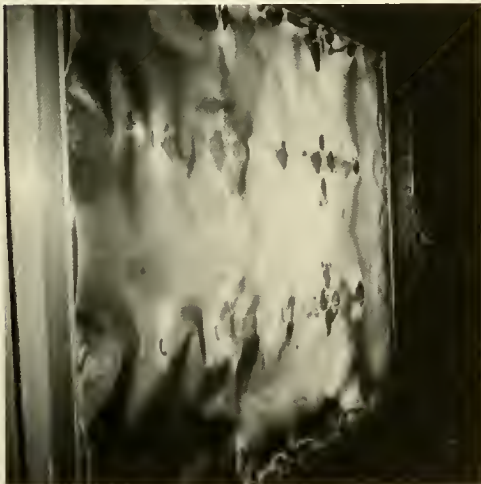
Figure 492 (Postflight). This oblique view shows the right side of the thermal cover, which appears less specular than the left side.

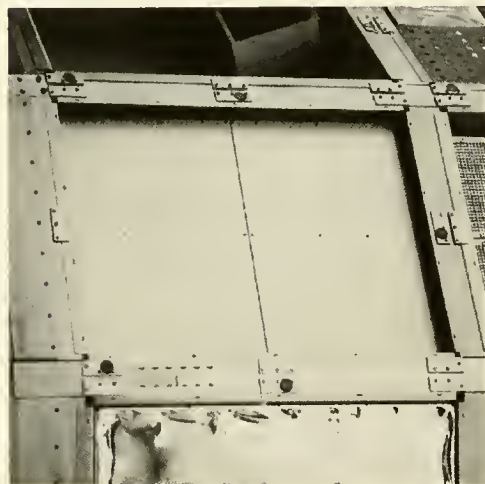
Figure 493 (In Flight). The greenish-gray and pink tints on the two debris panels are by-products of the chromic anodize coating process and are not attributed to contamination or exposure to the space environment. Fingerprints along the center edges of the debris panels indicate improper preflight handling and cleaning.

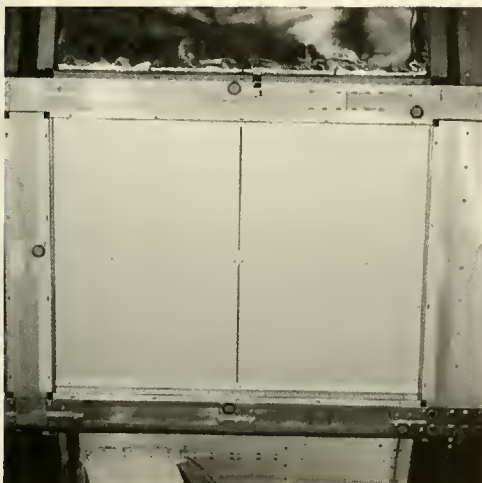
Figure 494
Photo No.: KSC-390C-1035.04
Dup. Neg. No.: L90-13449
LISAR No.: EL-1994-00182
Photo Credit: KSC
Photo Date: 2/9/90
Location: KSC SAEF II
Subject: Postflight Survey of Tray F5

Figure 494 (Postflight). The greenish-gray and pink tints on the two debris panels are by-products of the chromic anodize coating process and are not attributed to contamination or exposure to the space environment. The fingerprints along the center edges of the debris panels that were observed in the in-flight photograph are still visible. The light band across the bottom of the panels is caused by light reflecting from the tray sidewalls.

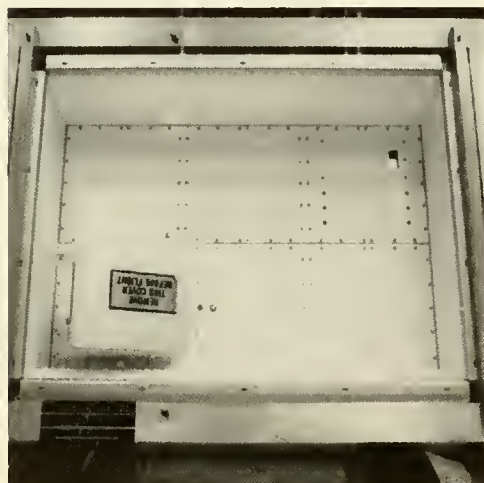
Figure 495 (Preflight). The prelaunch photograph shows a single experiment canister housing that was mounted in a 12-in-deep peripheral tray. The experiment canisters contained high-purity beryllium copper collecting foils. The aluminum housing cover, which was removed prior to flight, protected experiment components from damage and large particle contamination during ground handling. The tray is painted white to provide the necessary thermal control.

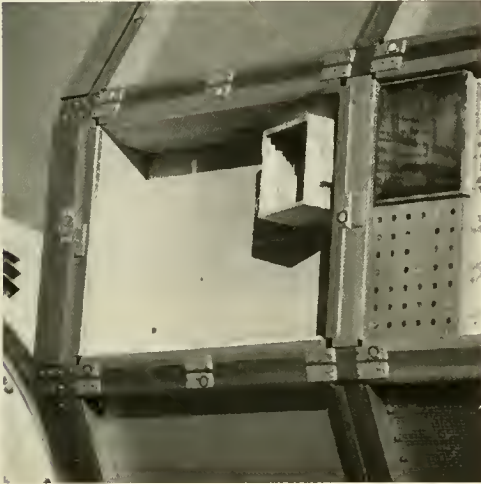
Figure 496
Photo No.: S32-82-002
Dup. Neg. No.: L90-10453
LISAR No.: EL-1994-00023
Photo Credit: JSC
Photo Date: 1/12/90
Location: In Flight
Subject: In-Flight Survey of Tray F6

Figure 496 (In Flight). Note the transition in color of tray clamp dots from white to brown, which indicates the transition from leading to trailing side. A handprint, not visible in the pre-flight photograph, is visible on the baseplate in the lower half of the experiment tray. The white dot near the lower corner of the end sidewall is a reflection of the test connector for the ground support equipment, which is located in the lower left corner of the baseplate. The two white dots on the experiment baseplate, near the left end of the tray, appear to be imperfections in the photograph because they were not observed during postflight inspection. The lighting and camera angle provide a clear view of the baffles located inside near the upper edges of the canister housing. The baffles seem to be relatively free of the brown contamination.

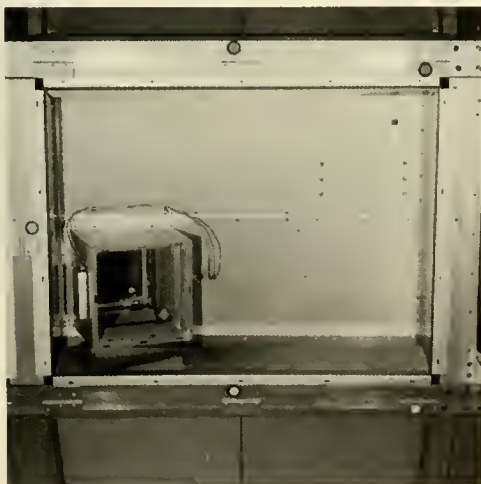
Figure 497
Photo No.: KSC-390C-1033.08
Dup. Neg. No.: L90-13438
LISAR No.: EL-1994-00178
Photo Credit: KSC
Photo Date: 2/9/90
Location: KSC SAEF II
Subject: Postflight Survey of Tray F6

Figure 497 (Postflight). The brown stains are uniform and prominent. The beryllium copper collector foil is clearly visible in this photograph, as are the baffles near the top of the canister housing. However, the fine wire mesh grid cannot be seen. Because of an experiment system malfunction, the canister collector foil that is visible was exposed for the total mission.

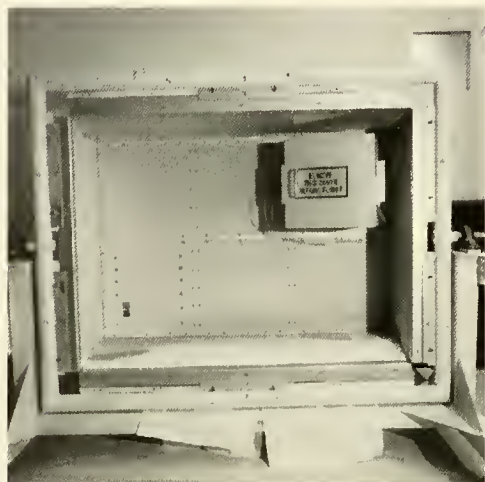
Figure 498
Photo No.: KSC-390C-1563.06
Dup. Neg. No.: L91-11327
LISAR No.: EL-1994-00291
Photo Credit: KSC
Photo Date: 3/5/90
Location: KSC SAEF II
Subject: Postflight Detail of Tray F6

Figure 498 (Postflight). This photograph is of the tray with one of the photographic lights turned off. The brown discoloration is uniform over the tray bottom; however, there is a heavier concentration on the lower left tray wall.

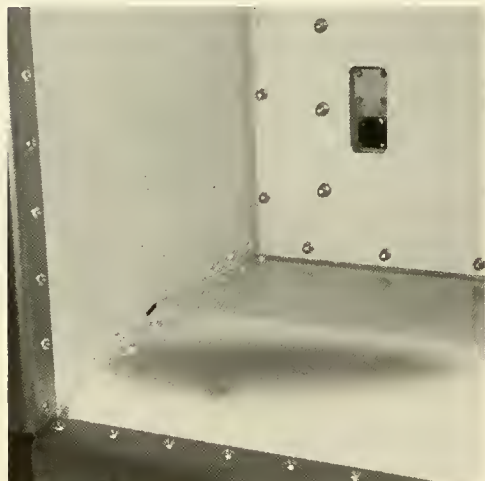
Figure 499
Photo No.: KSC-390C-1564.11
Dup. Neg. No.: L91-11343
LISAR No.: EL-1994-00292
Photo Credit: KSC
Photo Date: 3/5/90
Location: KSC SAEF II
Subject: Postflight Detail of Lower Left of Tray F6

Figure 499 (Postflight). This close-up photograph is of the lower left corner of the tray. There is an area of concentrated brown discoloration on the lower tray wall.

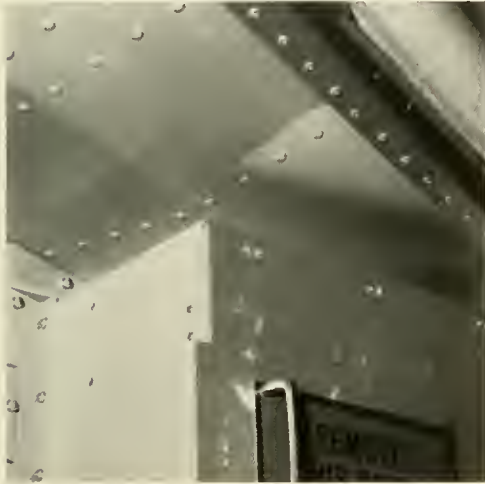
Figure 500
Photo No.: KSC-390C-1565.01
Dup. Neg. No.: L91-11344
LISAR No.: EL-1994-00293
Photo Credit: KSC
Photo Date: 3/5/90
Location: KSC SAEF II
Subject: Postflight Detail of Upper Left of Tray F6

Figure 500 (Postflight). This close-up photograph is of the upper right side of the canister box. The brown discoloration appears uniform, except there is a well-defined discoloration pattern of the canister on the upper tray wall. The cover was installed on the canister housing to protect the space-exposed hardware.

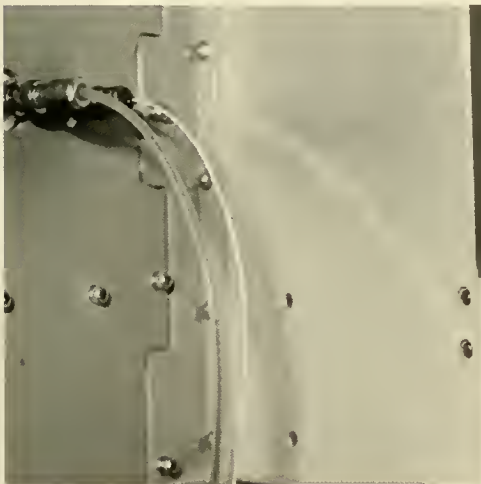
Figure 501
Photo No.: KSC-390C-1565.02
Dup. Neg. No.: L91-11345
LISAR No.: EL-1994-00308
Photo Credit: KSC
Photo Date: 3/5/90
Location: KSC SAEF II
Subject: Postflight Detail of Grid Voltage Plug Area of Tray F6

Figure 501 (Postflight). This close-up photograph is of the grid voltage plug area of the tray bottom and left side of the canister box. Note the distinct discoloration pattern of the electrical leads on the canister wall.

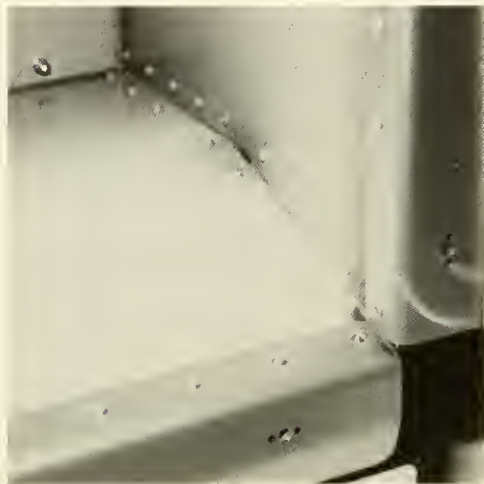
Figure 502
Photo No.: KSC-390C-1565.04
Dup. Neg. No.: L91-11347
LISAR No.: EL-1994-00309
Photo Credit: KSC
Photo Date: 3/5/90
Location: KSC SAEF II
Subject: Postflight Detail of Lower Right Corner of
Tray F6

Figure 502 (Postflight). This close-up photograph is of the lower right corner of the tray and shows the contrast in discoloration of the side walls.

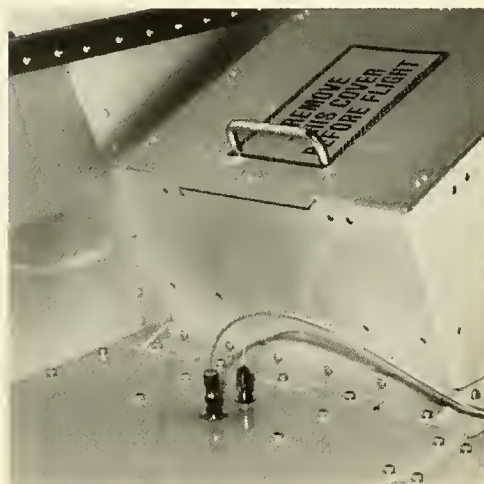
Figure 503
Photo No.: KSC-390C-1565.08
Dup. Neg. No.: L91-11350
LISAR No.: EL-1994-00115
Photo Credit: KSC
Photo Date: 3/5/90
Location: KSC SAEF II
Subject: Postflight Detail of Canister Area of
Tray F6

Figure 503 (Postflight). This close-up photograph shows the discoloration pattern of the canister on the tray wall. Also note the faint discoloration pattern of the electrical lead on the canister wall and a shadow resulting from the photographic light below. The cover was installed on the canister housing to protect the space-exposed hardware.

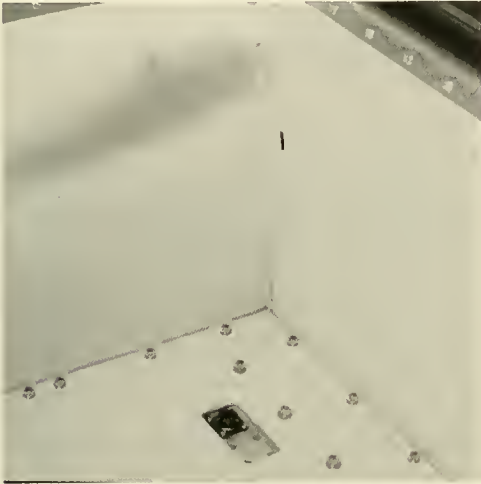
Figure 504 (Postflight). This close-up photograph of the lower left corner of the tray shows the contrast in amount of discoloration.

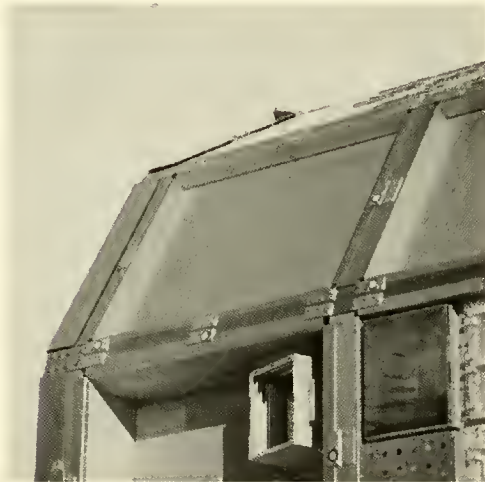
Figure 505 (In Flight). Note the transition of the tray clamp dot color. The discolorations on the upper tray sidewall appear to be fingerprints from handling during the experiment assembly. A portion of the pink and greenish-gray tint on the two debris panels is a by-product of the chromic anodize coating process; however, a part of the intensity can be attributed to reflections of the blue sky. The horizontal streaks on the right debris panel and the vertical streaks on the left debris panel are by-products of chromic anodizing that have been enhanced by the blue reflection. The light band along the vertical edge of the debris panel is a reflection from the tray sidewall.

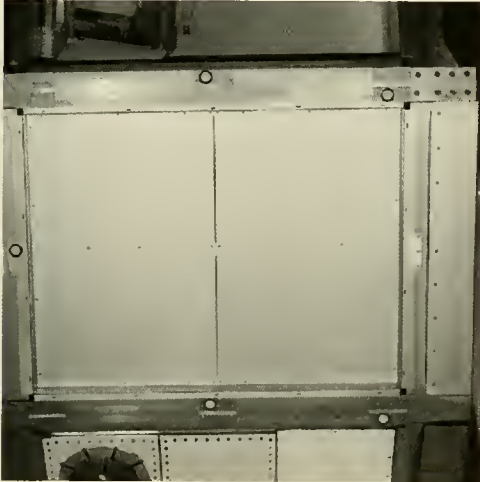
Figure 506 (Postflight). The pink and greenish-gray tints on the two debris panels are by-products of the chromic anodize coating process and are not attributed to contamination or exposure to the space environment. The streaks on the debris panels in the in-flight photographs are almost invisible because the reflection of the sky is not present. The light band along the sides and across the bottom of the panels is caused by light reflecting from the tray sidewalls.

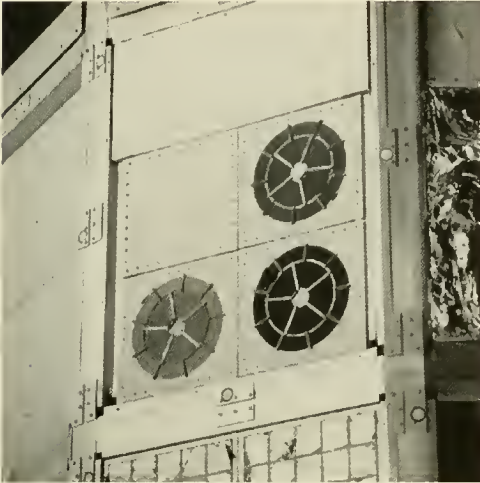
Figure 508 (In Flight). The coils have changed color. The upper right coil, originally glossy black, now appears to be dark brown. The lower right coil, originally a glossy royal blue, now appears to be navy blue. The two 20-m coils of linked fiber optic cables in the lower left have more extensive color changes. The exterior cable that was originally yellow now appears to be slate gray and the interior cable that was light tan appears to be brown.

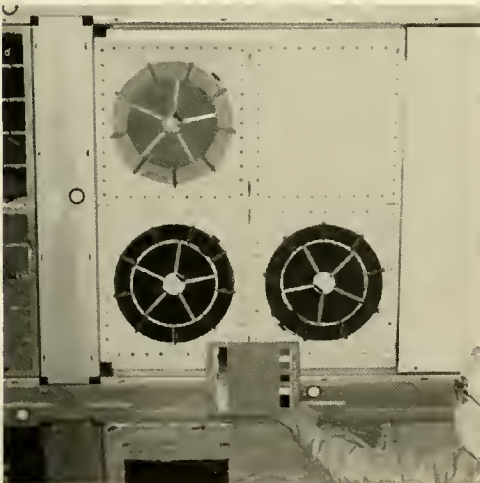
Figure 509 (Postflight). Colors of all three exposed coils of fiber optic cables have changed significantly. The lower right cable, which was originally glossy black, is now dark brown. The lower left cable, which was originally glossy royal blue, is now navy blue. The upper left cable, which was originally yellow and that was slate gray in flight, is now light gray. The cable that was brown in flight is now a lighter brown. The Chemglaze white paint on the large cover plate has maintained the prelaunch color, but the IITRI S13G-LO white paint on the small cover plate has changed to a uniform light tan.

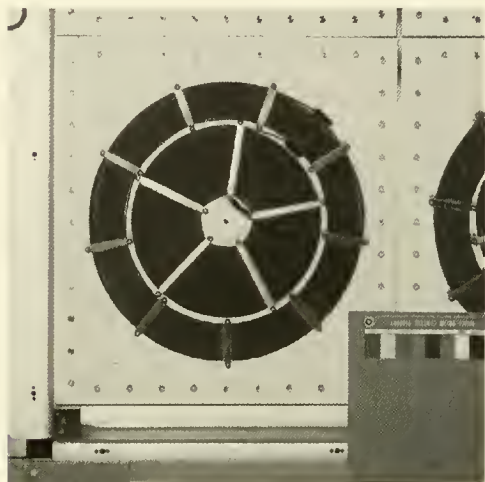
Figure 510 (Postflight). This photograph is of the lower left coil of fiber optic cable. The cable was originally a glossy royal blue, but it is now a darker, duller navy blue. The color of the silicone-rubber spacers under the coil attachment clips has changed from clear to brown. The spacers appear to have discolored the cables. Brown discolorations have appeared at the lower left corner of the tray.

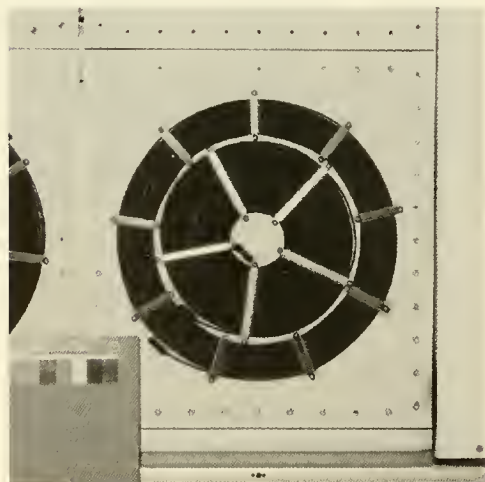
Figure 511 (Postflight). This photograph is of the lower right coil of fiber optic cable. The cable that was originally glossy black is now dark brown. The color of the silicone-rubber spacers under the coil attachment clips has changed from clear to brown. The spacers have discolored the cables. There is some discoloration near the lower right corner of the coil mounting plate

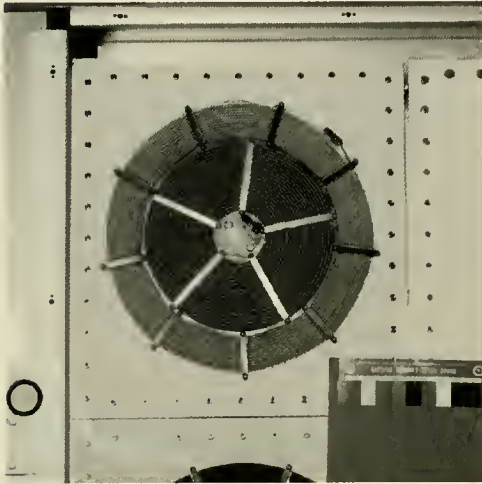
Figure 512 (Postflight). This photograph is of the two 20-m coils of fiber optic cables in the upper left part of the tray. These coils have more extensive color changes than the other coils. The cable that was originally yellow and that was slate gray in the in-flight photograph, is now a light gray. The cable that was brown in the in-flight photograph, now is a lighter brown. The color of the silicone-rubber spacers under the coil attachment clips has changed from clear to brown. The spacers appear to have discolored the cables. There is also discoloration on the mounting plate just above the coils and on the tray at the upper left corner.

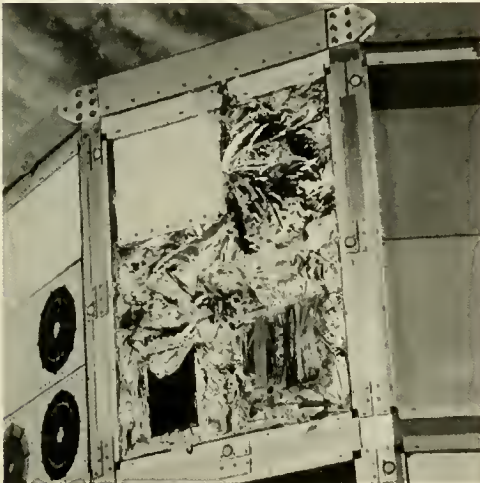
Figure 514 (In Flight). Aluminum particles from the degraded thermal blanket of experiment AO076 are visible on the upper structure intercostal. There is a line of dark discoloration on this intercostal that was adjacent to the edge of the space end thermal panel. An area underneath the edge of the thermal panel allowed venting of the LDEF interior. The external materials of experiment AO076 have changed significantly. The Kapton film on the thermal blanket appears to be completely eroded, except under the buttons that were used to secure the blanket. The erosion left only a very thin coating of vapor-deposited aluminum as a cover. Aluminum coating residue has covered a portion of the black chrome solar collector and also areas of the upper and lower flanges of the trays. The shadow on the tray lower flange indicates that the aluminum extends several inches beyond the tray. One of two thin-film atomic oxygen experiment patches is gone and the other does not appear to be securely attached. The layer of Kapton tape over the thin-film strips appears to be eroded with only the adhesive remaining. The remaining atomic oxygen experiment materials have changed color and most appear to be severely degraded. The silvered Teflon coating of the radiator panel appears diffuse with a light brown discoloration over most of the surface. The black spots on the radiator panel appear to be impact craters where debris penetrated the Teflon material and exposed the silver beneath to atomic oxygen flux. Particles of the degraded thermal blanket material appear to be adhered to the surface of the radiator panel.

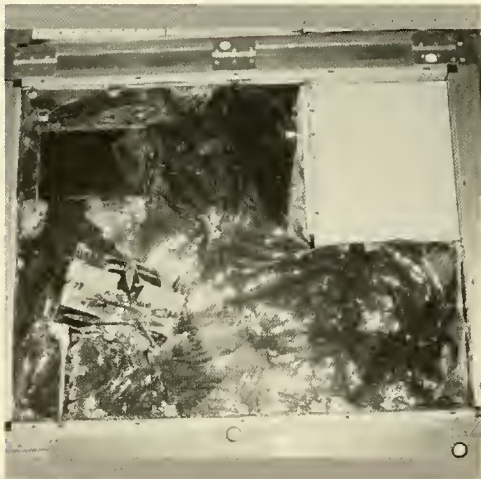
Figure 515 (Postflight). The LDEF structure with the intercostal on the right has a dark brown discoloration that is adjacent to the edge of the space end thermal panel. An area underneath the edge of the thermal panel allows venting of the LDEF interior. Aluminum pieces of the degraded experiment AO076 thermal cover that were lodged in the vent in the in-flight photograph are gone. The external surface of the experiment AO076 has changed dramatically from that observed in the in-flight photograph. The thin coating of vapor-deposited aluminum, which was left after the Kapton film eroded, is essentially gone; only fragments of the coating are left near the edges of the thermal blanket. Pieces of Dacron mesh (bridal veil) material, which was used to separate the thermal cover from the thermal blanket and between sheets of aluminized Kapton film in the thermal blanket, are visible along the edges of the blanket and near the buttons that were used to secure the blanket. A large fragment of the Dacron mesh is folded over the left side of the radiator panel. The large discoloration on the right side of the black chrome solar collector panel is approximately the same shape as the aluminum coating that covered the area in the in-flight photograph. The orientation of the remaining thin-film atomic oxygen experiment patch indicates that the patch is attached to the Dacron mesh and that the attachment is very fragile. The layer of Kapton tape that covered the ends of the thin-film strips appears to have eroded, thus exposing the adhesive. The remaining materials of the atomic oxygen experiment have changed color; most are severely degraded. The silvered Teflon coating of the radiator panel appears diffuse with a light brown discoloration over most of the surface. The white, evenly spaced, discolorations along the horizontal centerline and along the edges of the panel appear to be above countersunk flat head screws used to assemble the experiment. The black spots on the radiator panel appear to be impact craters that penetrated the Teflon material and exposed the silver beneath to atomic oxygen flux. Particles of the degraded thermal blanket material, which appeared to adhere to the surface of the radiator panel in the in-flight photograph, are gone.

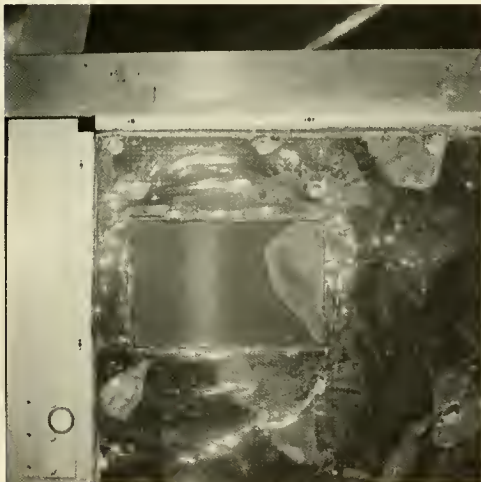
Figure 517 (Postflight). This photograph is of the upper left one-sixth of the tray. The thin coating of vapor-deposited aluminum, left after the Kapton film eroded, is essentially gone and only fragments of the thermal blanket remain. Pieces of Dacron mesh material are visible along the edges of the blanket and near the buttons that were used to secure the blanket. The large area of discoloration on the right side of the black chrome solar collector panel appears to be approximately the same shape as the aluminum coating that covered the area in the in-flight photograph.

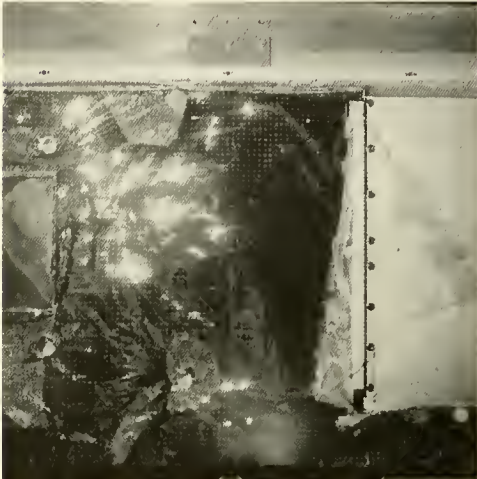
Figure 518 (Postflight). This photograph is of the upper center one-sixth of the tray. The thin coating of vapor-deposited aluminum, left after the Kapton film eroded, is essentially gone and only fragments of the thermal blanket remain. Pieces of Dacron mesh are visible along the edges of the blanket and near the buttons that were used to secure the blanket. A large fragment of the Dacron mesh is folded over the left side of the radiator panel.

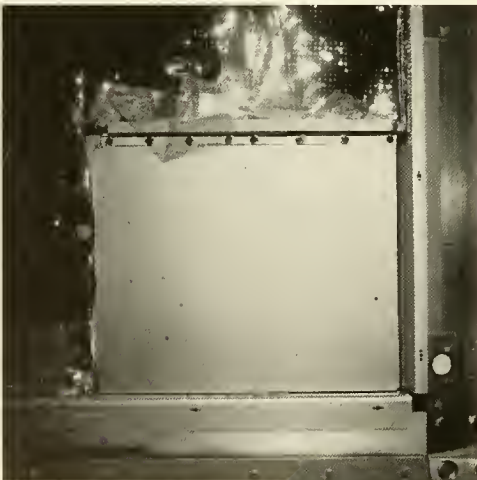
Figure 519 (Postflight). This photograph is of the upper right one-sixth of the tray. The thin coating of vapor-deposited aluminum, left after the Kapton film eroded, is essentially gone and only fragments of the thermal blanket remain. Small discolorations that were caused by impacts are visible on the silvered Teflon film surface of the radiator. Pieces of Dacron mesh are visible. The fragment that covered the left side of the radiator panel has moved to the left.

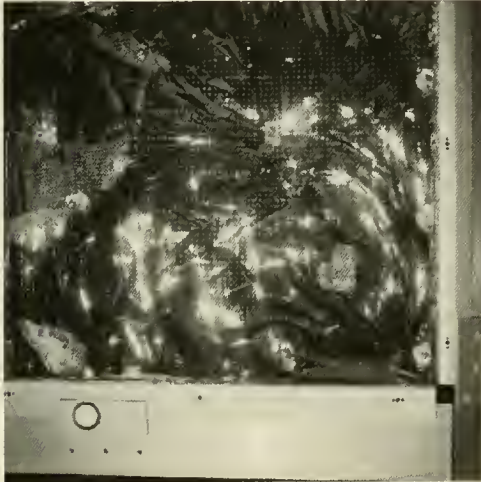
Figure 520 (Postflight). This photograph is of the lower left one-sixth of the tray. The thin coating of vapor-deposited aluminum, left after the Kapton film eroded, is essentially gone and only fragments of the thermal blanket remain. Pieces of Dacron mesh are visible along the edges of the blanket and near the buttons that were used to secure the blanket.

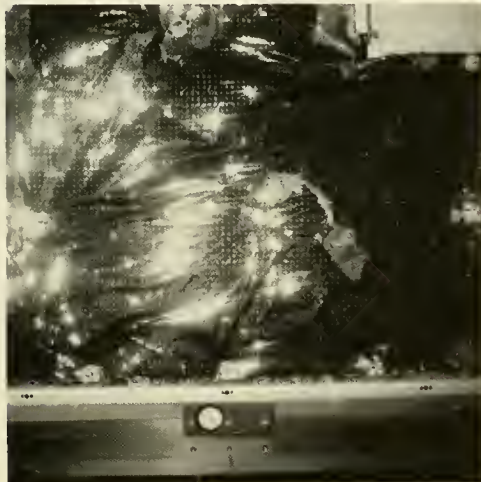
Figure 521 (Postflight). This photograph is of the lower center one-sixth of the tray. The thin coating of vapor-deposited aluminum, left after the Kapton film eroded, is essentially gone and only fragments of the thermal blanket remain. Pieces of Dacron mesh are visible along the edges of the blanket and near the buttons that were used to secure the blanket.

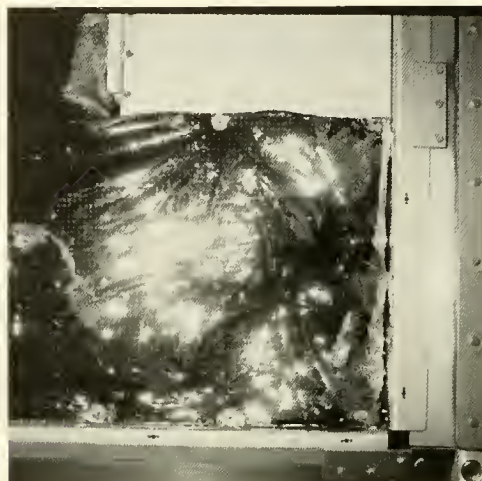
Figure 522 (Postflight). This photograph is of the lower right one-sixth of the tray. The thin coating of vapor-deposited aluminum, which was left after the Kapton film eroded, is essentially gone and only fragments of the thermal blanket remain. Pieces of Dacron mesh are visible along the edges of the blanket and near the buttons that were used to secure the blanket. Note the dark brown discoloration at the edge of the thermal panel at the right.

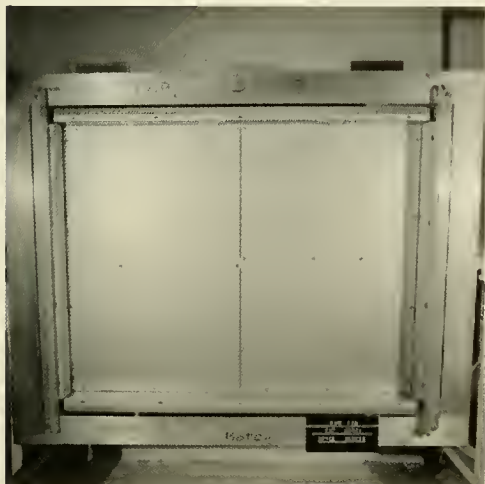
Figure 523 (Postflight). The green tint on the two debris panels is a by-product of the chromic anodize coating process and is not attributed to contamination or exposure to the space environment. A light irregular vertical streak is on the right debris panel. The light band across the top and bottom edges of the panels is caused by light reflecting from the tray sidewalls.

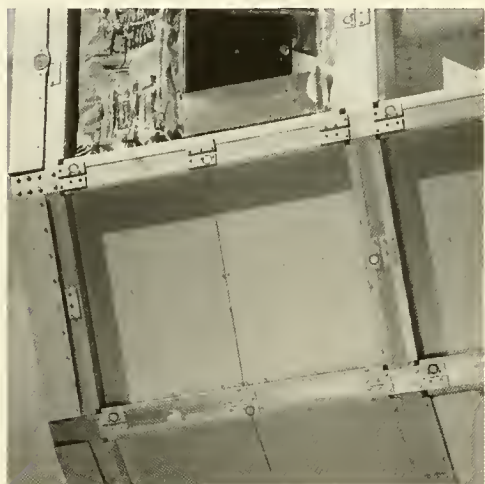
Figure 524 (In Flight). A portion of the greenish-gray tint on the two debris panels is a by-product of the chromic anodize coating process; however, some blue can be attributed to reflection of the sky. The vertical streaks on the right debris panel are by-products of chromic anodizing that have been enhanced by the blue reflection. The brown stains along the top edge of the right debris panel appear to be fingerprints from prelaunch handling.

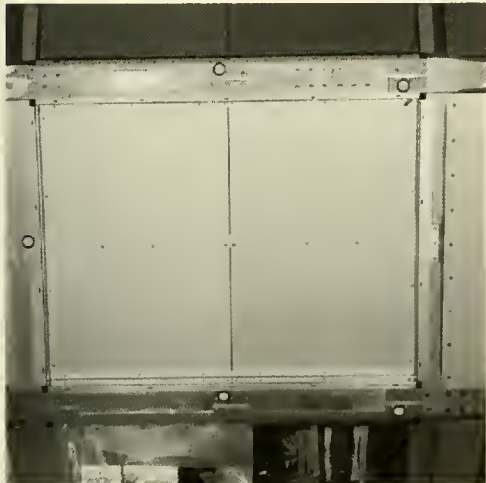
Figure 525 (Postflight). The pink and greenish-gray tints on the two debris panels are by-products of the chromic anodize coating process and are not attributed to contamination or exposure to the space environment. Debris from other experiments that degraded during the mission is visible on the lower experiment tray sidewall at the intersection with the right tray sidewall. A larger piece is located in the upper right corner on the right debris panel. Other experiment debris, which are visible as dark specks, are at the intersection of the debris panel outer edges and the tray sidewalls. The light band along the sides and across the bottom of the panels is caused by light reflecting from the tray sidewalls.

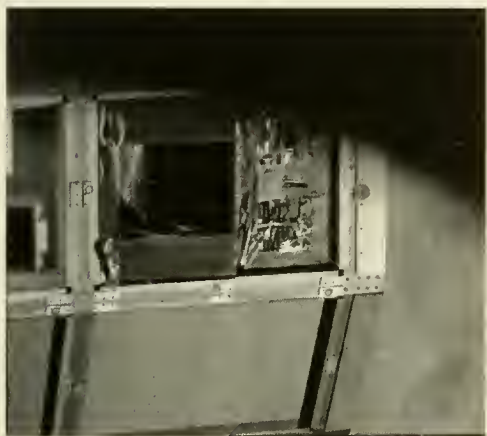
Figure 527 (In Flight). The radiator and the radiator shields appear deep blue, which is apparently caused by the lighting and the reflecting surface. The upper and lower radiator side shields are discolored by a brown stain that is visible through the deep blue. The Teflon tape used to provide continuity between the side shield and end shield appears to be only secured at the outer edges. The tape and the areas initially covered by the tape appear discolored. The external thermal control blanket appears to be in good condition; however, the lower patch of the atomic oxygen experiment materials has many severely degraded samples. Several of the materials have sections that have eroded away and remain attached at only one end. Others are to be completely gone. The materials in the upper patch appear to have survived better, but they are wrinkled and have distorted shapes.

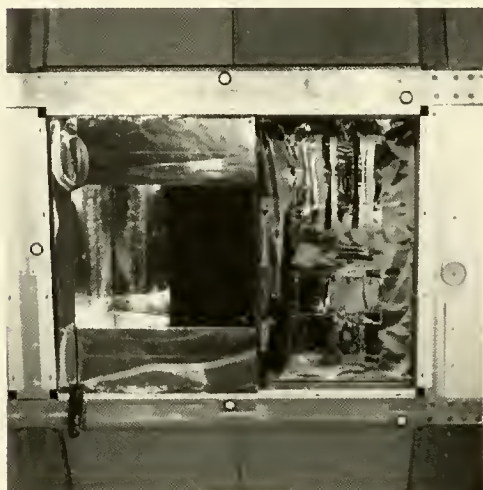
Figure 528
Photo No.: KSC-390C-1069.08
Dup. Neg. No.: L90-13488
LISAR No.: EL-1994-00190
Photo Credit: KSC
Photo Date: 2/8/90
Location: KSC SAEF II
Subject: Postflight Survey of Tray F12

Figure 528 (Postflight). The upper and lower radiator shields have fine vertical marks that may be cracks or abrasions on the surfaces and are discolored by a brown stain. A darker brown stain appears at the intersection of the end shield sections and in the lower left corner where the silvered Teflon tape, which is hanging over the LDEF structure, has pulled away. The area initially covered by the tape appears clean and is outlined by a vertical line of discolored material. The external thermal control blanket has cracks and tears near the intersection with the radiator; it appears more fragile than in the prelaunch photograph. The lower patch of atomic oxygen experiment materials has many severely degraded samples. Several of the materials have sections eroded away and remain attached at only one end. Other materials are completely gone or have only fragments that remain. The materials in the upper patch have survived better, but are eroded, wrinkled, and have distorted shapes. Discolorations that appear to be pieces of Kapton tape lie horizontally across the lower third of the upper patch of materials. Another piece of Kapton tape lies horizontally across the center of the lower patch of material samples.

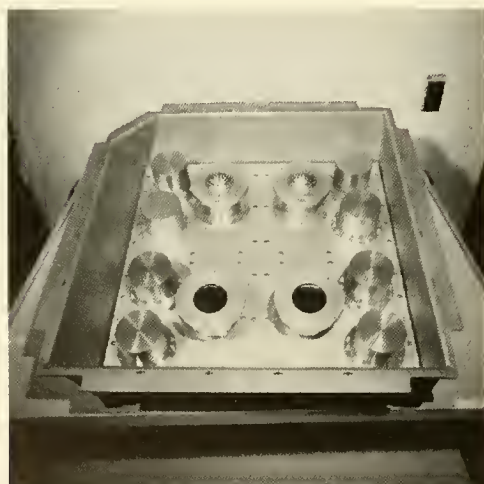
Figure 531
Photo No.: KSC-390C-1938.09
Dup. Neg. No.: L91-11607
LISAR NO.: EL-1994-00282
Photo Credit: KSC
Photo Date: 3/14/90
Location: KSC SAEF II
Subject: Postflight Survey of Tray G2

Figure 531 (Postflight). The experiment appears to have survived the extended mission with no visible damage. The experiment housings are intact and all hardware is securely in place. The detector housings appear to have a stain that is similar to that on the tray hardware. The Kapton H foil that covered windows in two detector housings does not appear to have been damaged during the extended mission. The perforated dome on two of the detector housings has a slight tan discoloration, but there is no indication of damage.

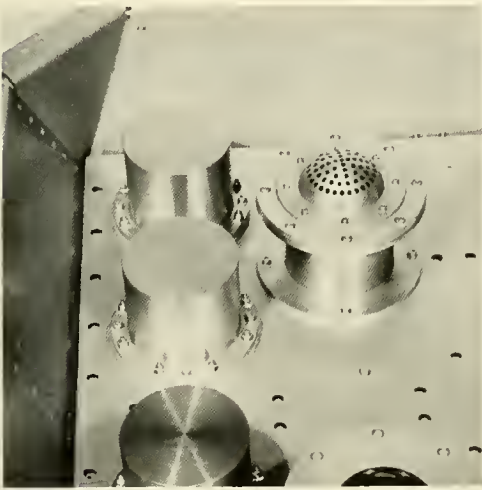
Figure 532 (Postflight). This photograph is of the upper left one-fourth of the tray. The experiment housings are intact and all hardware is securely in place. The detector housings appear to have a light stain.

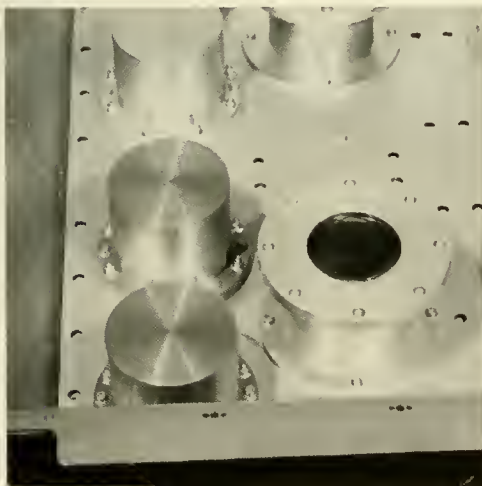
Figure 533 (Postflight). This photograph is of the lower left one-fourth of the tray. The experiment housings are intact and all hardware is securely in place. The detector housings appear to have a light stain.

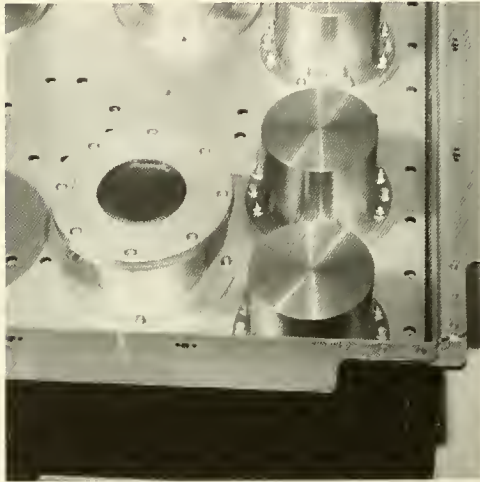
Figure 534 (Postflight). This photograph is of the lower right one-fourth of the tray. The experiment housings are intact and all hardware is securely in place. The detector housings appear to have a light stain.

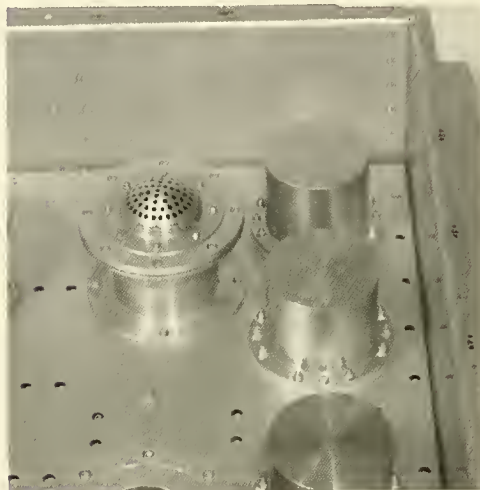
Figure 535 (Postflight). This photograph is of the upper right one-fourth of the tray. The experiment housings are intact and all hardware is securely in place. The detector housings appear to have a light stain.

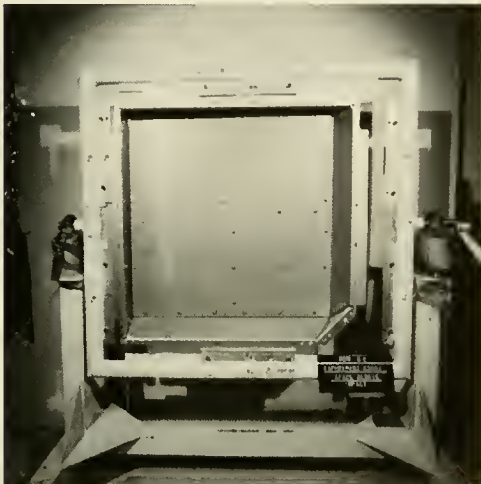
Figure 536 (Postflight). The light pink tint of the debris panel is a by-product of the chromic anodize coating process and is not attributed to contamination or exposure to the space environment. A brown stain is located in the lower right corner of the tray.

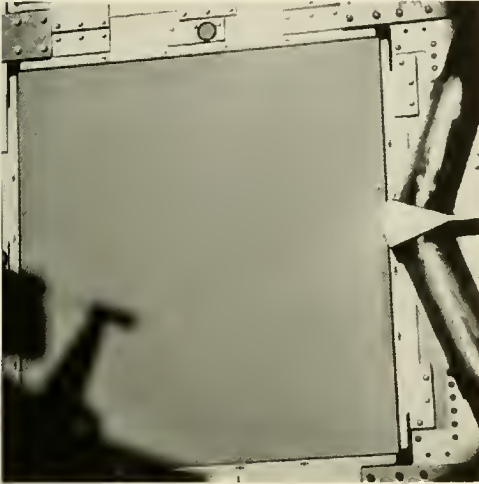
Figure 538
Photo No.: S32-76-066
Dup. Neg. No.: L90-10391
LISAR NO.: EL-1994-00081
Photo Credit: JSC
Photo Date: 1/12/90
Location: In Flight
Subject: In-Flight Survey of Tray G6

Figure 538 (In Flight). The cover plate appears brown because of the lighting. Later photographs indicated that the cover was a slightly discolored white. The narrow band of discolorations at the right, left, and upper edges of the cover plate appears to be areas of masking tape residue that have turned brown.

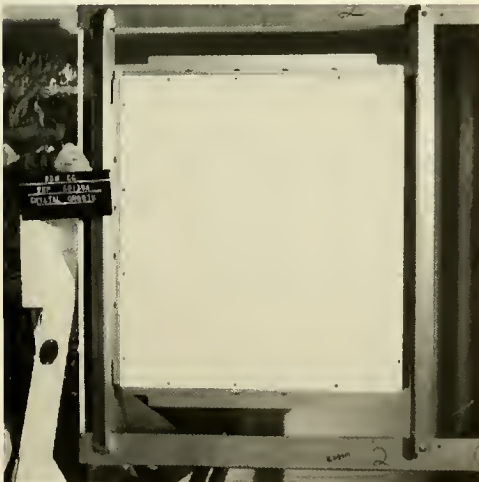
Figure 539
Photo No.: KSC-390C-1704.05
Dup. Neg.: L91-11642
LISAR NO.: EL-1994-00265
Photo Credit: KSC
Photo Date: 3/7/90
Location: KSC SAEF II
Subject: Postflight Survey of Tray G6

Figure 539 (Postflight). Experiment (AO139A) appears to have survived the extended mission with no visible damage. Some discoloration appears near the center of the left flange of the tray. The experiment cover plate, which was originally white, is discolored by a very light brown stain, but it is intact and securely in place.

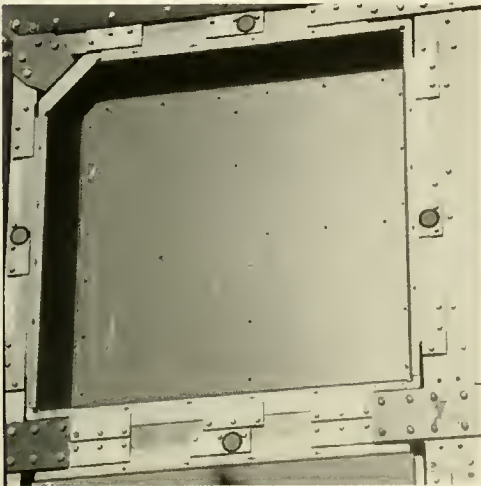
Figure 541 (In Flight). The darkness in the left section of the debris panel is attributed to the lighting, although the panel appears to have a light discoloration. The scrapes and scratch marks are from preflight handling and are not mission related.
